LUND UNIVERSITY | LUND INSTITUTE OF TECHNOLOGY  
Division of Structural Mechanics | Sweden 1998 | Report TVSM-5087

## STRUCTURAL ANALYSIS OF THE ROOF STRUCTURE IN THE REFORMED CHURCH

Master's thesis by PETRA DIKE and SARA MACDONALD MALMBERG

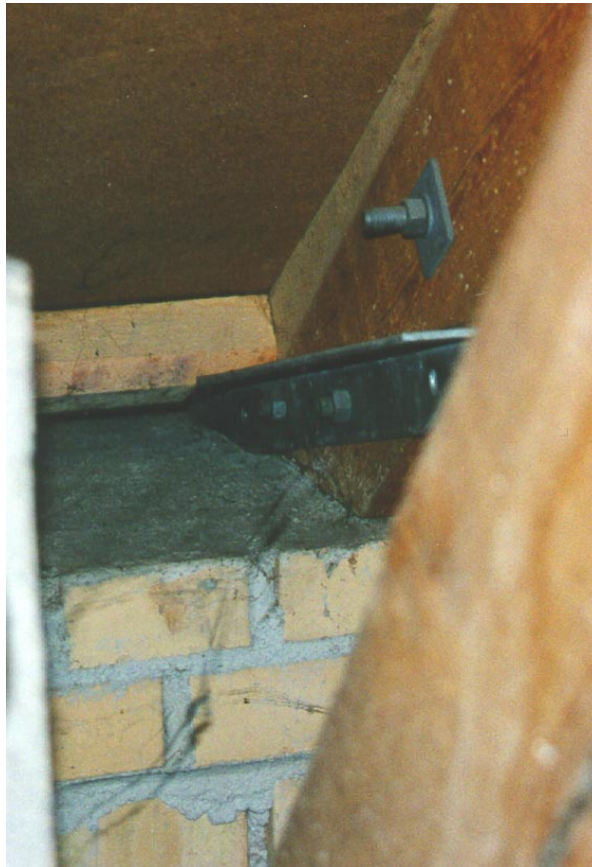
*Picture 6.1 The hiping beam furthest out in the structure.*

On the sides of the hiping beams there are flat bars of iron screwed into it, see Picture 6.1 and Figure 6.9. These bars are present to carry the drainpipe and have no other load carrying function.

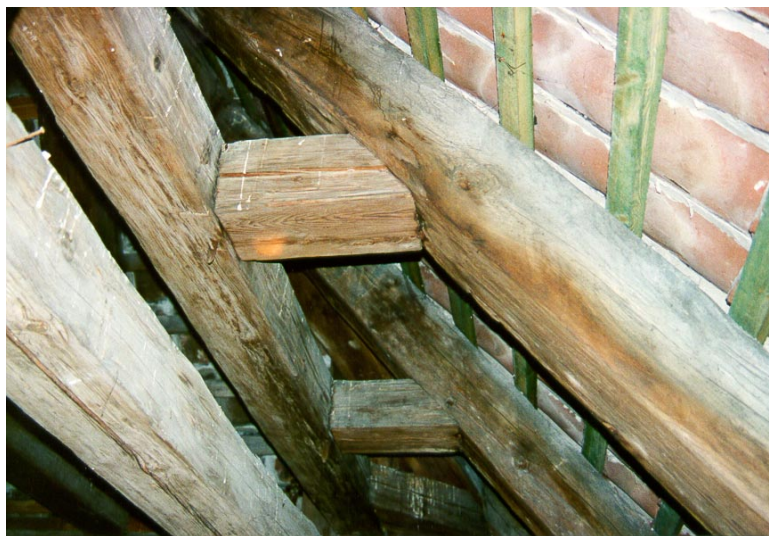
Picture 7.1 *The beam supporting the rafter, seen from below.*

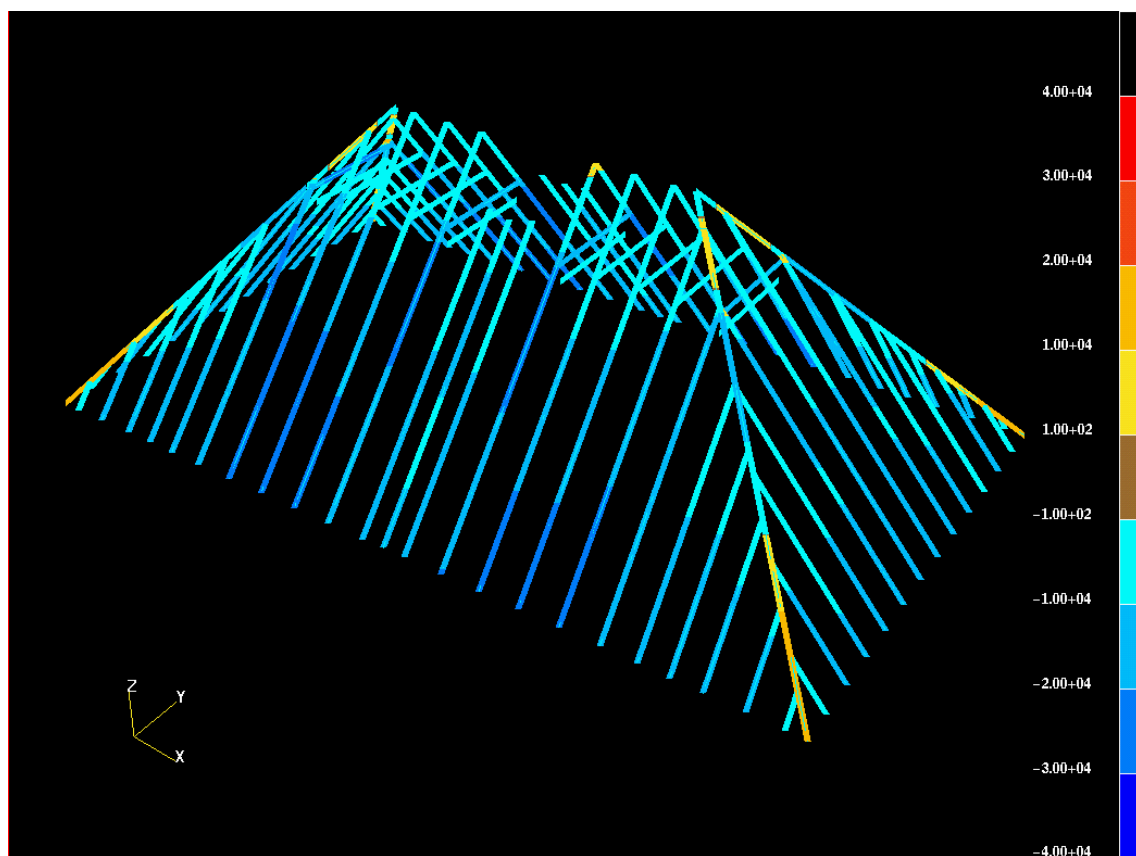
Figure 7.6 The primary load path, represented by the outer rafters. Force scale from  $-40$  kN to  $40$  kN.

An increase in the compressive forces in the outer rafters is also caused since the queen posts are partly suspended from them. This results in a load less than 10 kN, which can be carried by the tenon joint at the top of the queen posts [3].

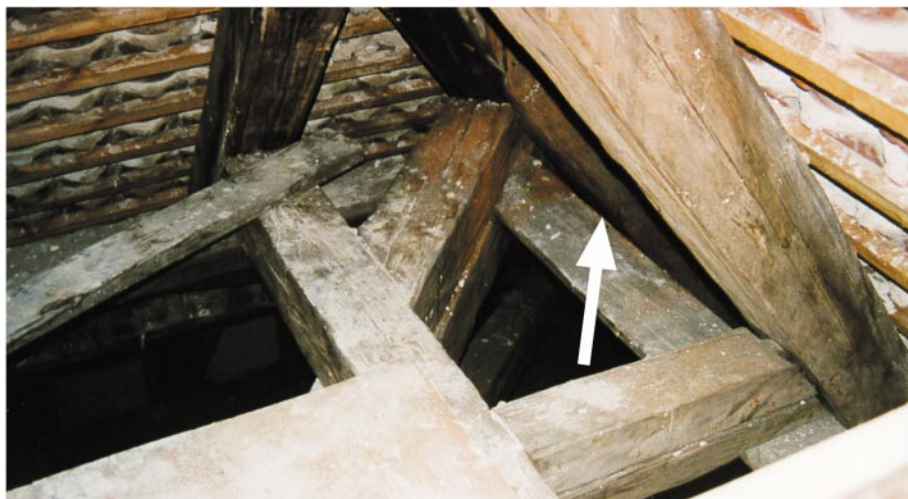
Picture 7.2 The picture shows the space between the rafters and the lying timberframe.

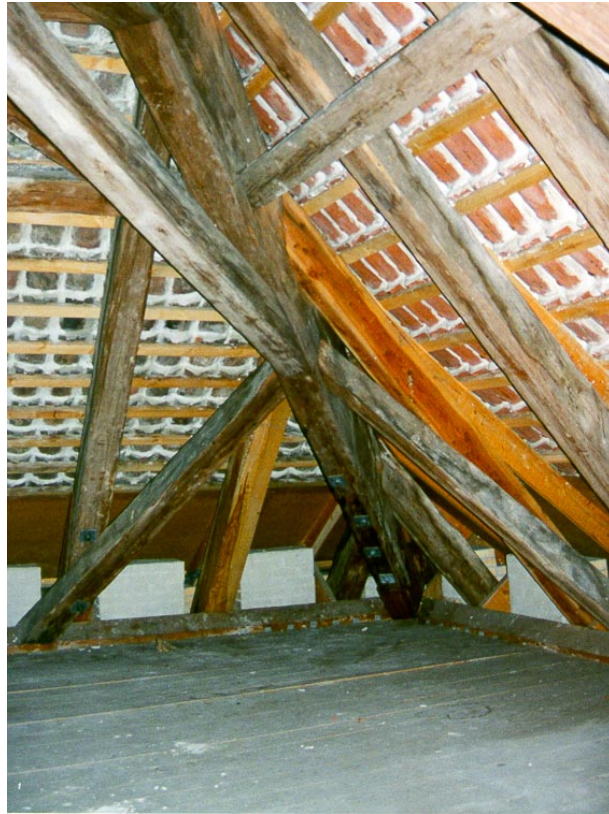
*Picture 7.3 Geometry in the corner.*
