TESTS OF FULL SIZE RUBBER FOIL ADHESIVE JOINTS

PER JOHAN GUSTAFSSON

Department of Construction Sciences
Structural Mechanics

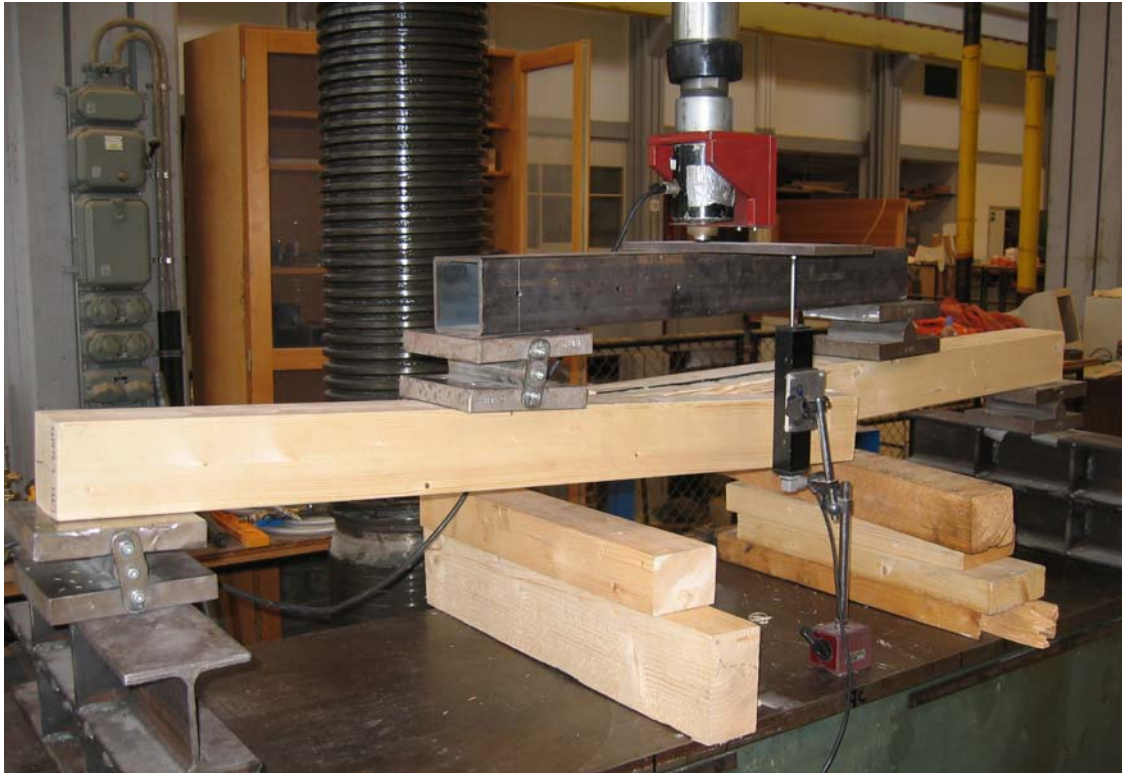
Test no.	P_f kN	δ_f mm	σ_f MPa	Cause of failure
I	19.0	19.2	33.9	Fracture in the wood: rolling shear, longitudinal shear and perp. to grain tension.
II	21.2	19.8	37.8	Fracture in the wood: rolling shear, longitudinal shear and perp. to grain tension.
III	22.6	17.8	40.3	Fracture in the wood: rolling shear.

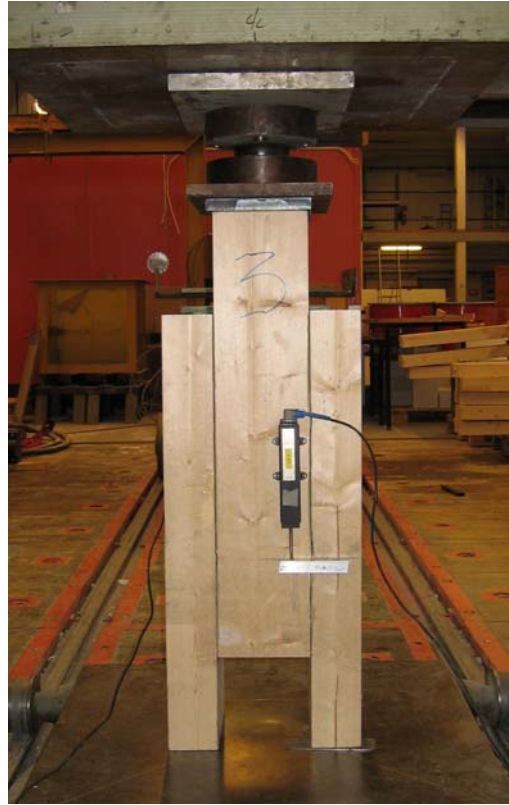
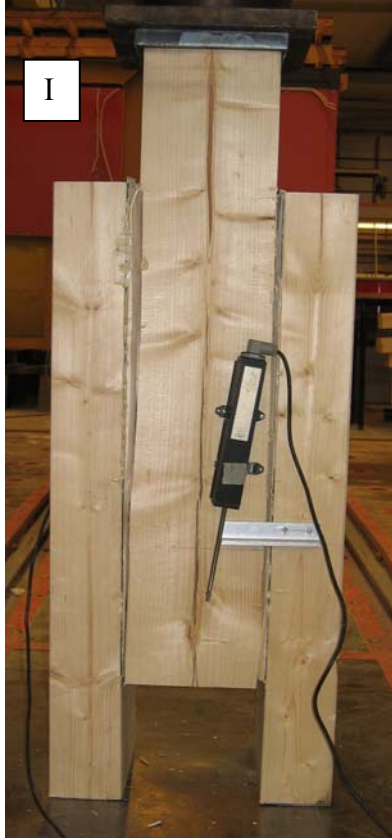
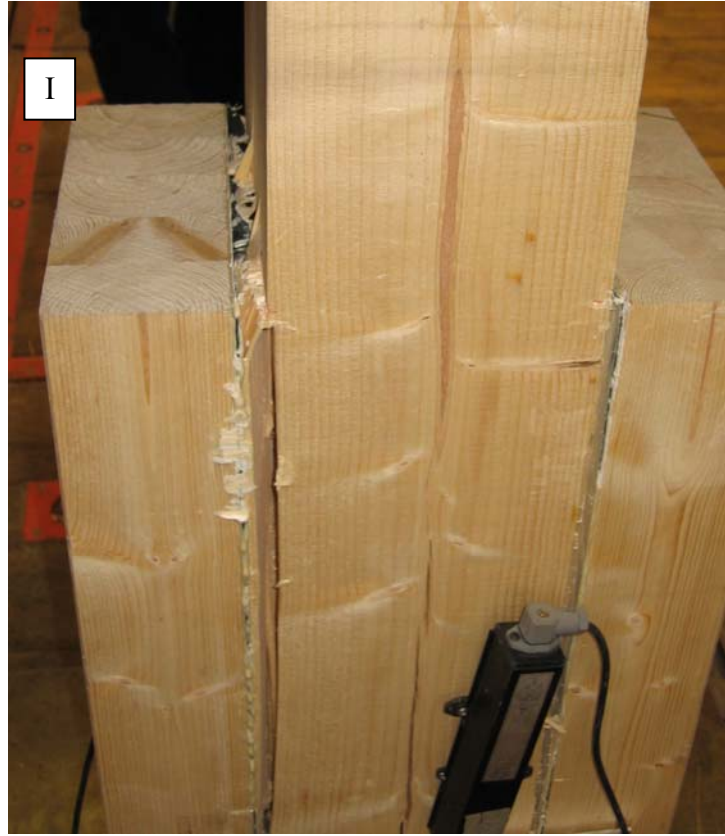
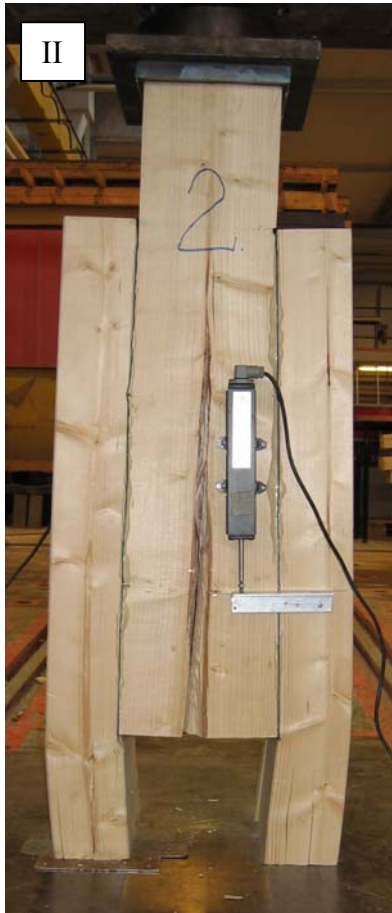
Test no.	P_f kN	δ_f mm	τ_f MPa	σ_f MPa	Cause of failure
I	1227	4.11	4.58	33.8	Shear failure in the wood along the bond area.
II	1188	3.77	4.44	32.7	Compressive bending failure of the wood.
III	1109	2.48	4.14	30.5	Shear failure in the wood perpendicular to and along part of the bond area, possibly due to non-uniform contact between the specimen and the supporting steel plate.

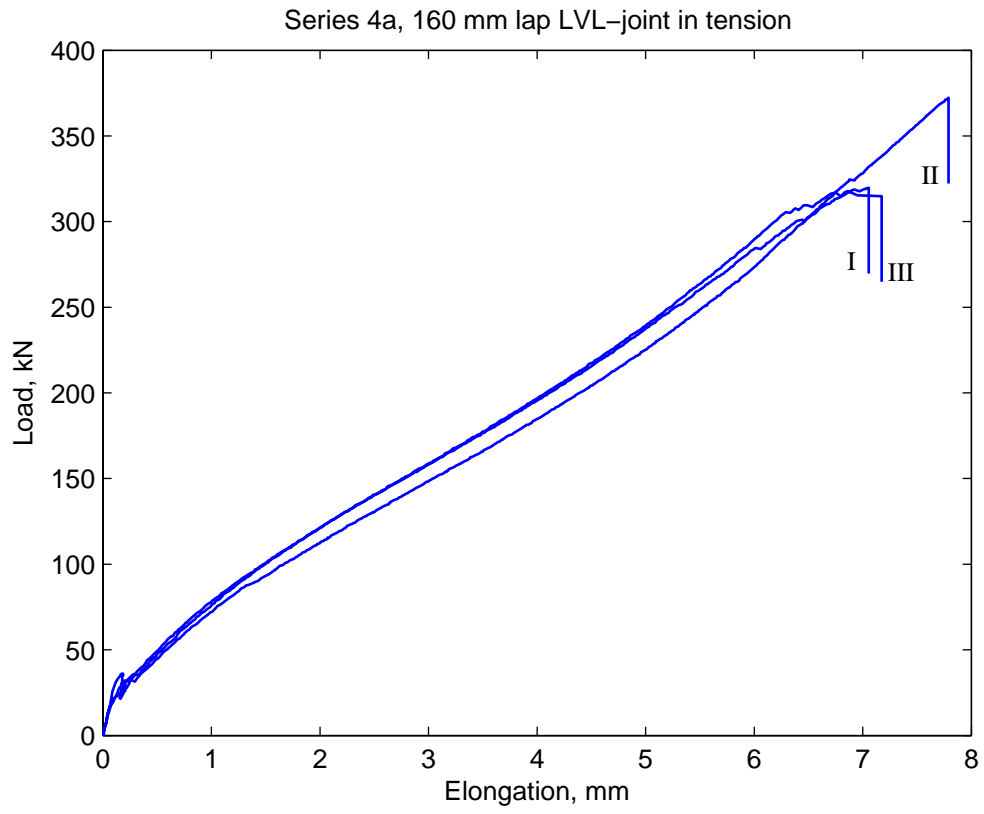
The test results are indicated in the below table, diagram and pictures. The notations used for type of failure is defined in the below figure. σ_f indicates the mean tensile stress in the LVL at failure.

Test no.	P_f kN	δ_f mm	τ_f MPa	σ_f MPa	Failure, "left"	Failure, "right"
I	202.4	6.25	2.84	16.7	Shear-KL	Shear-KQ
II	212.8	6.72	2.99	17.5	Shear-KL	Shear-KL
III	203.9	6.28	2.86	16.8	Shear-KL	Shear-KL

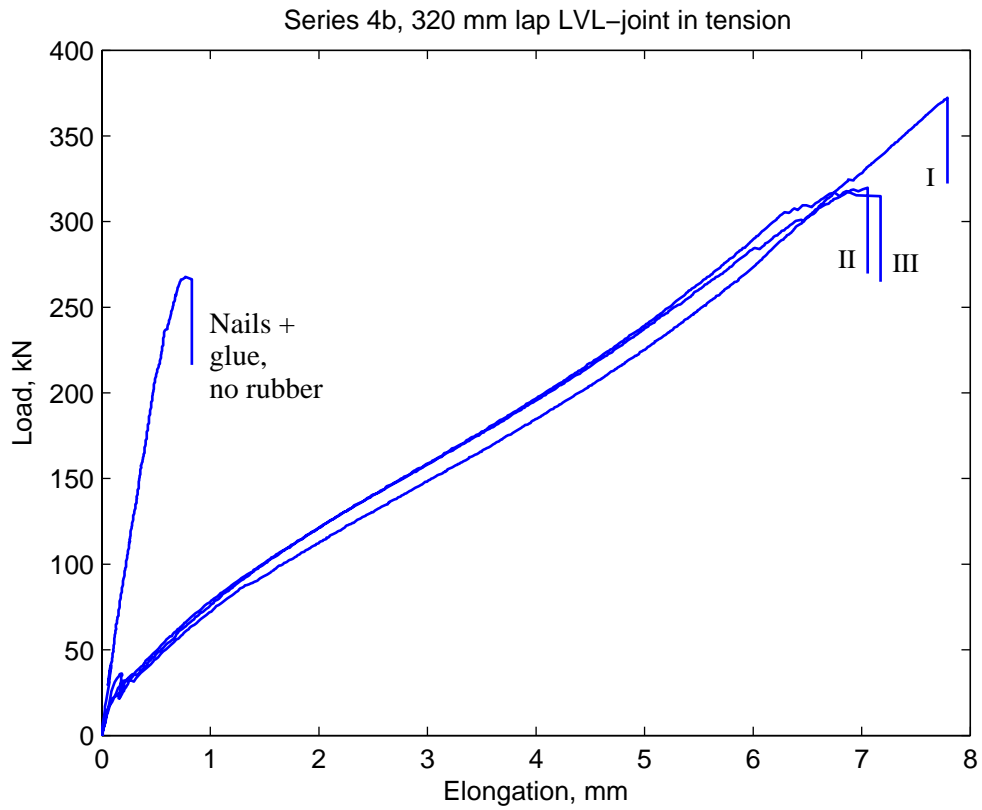
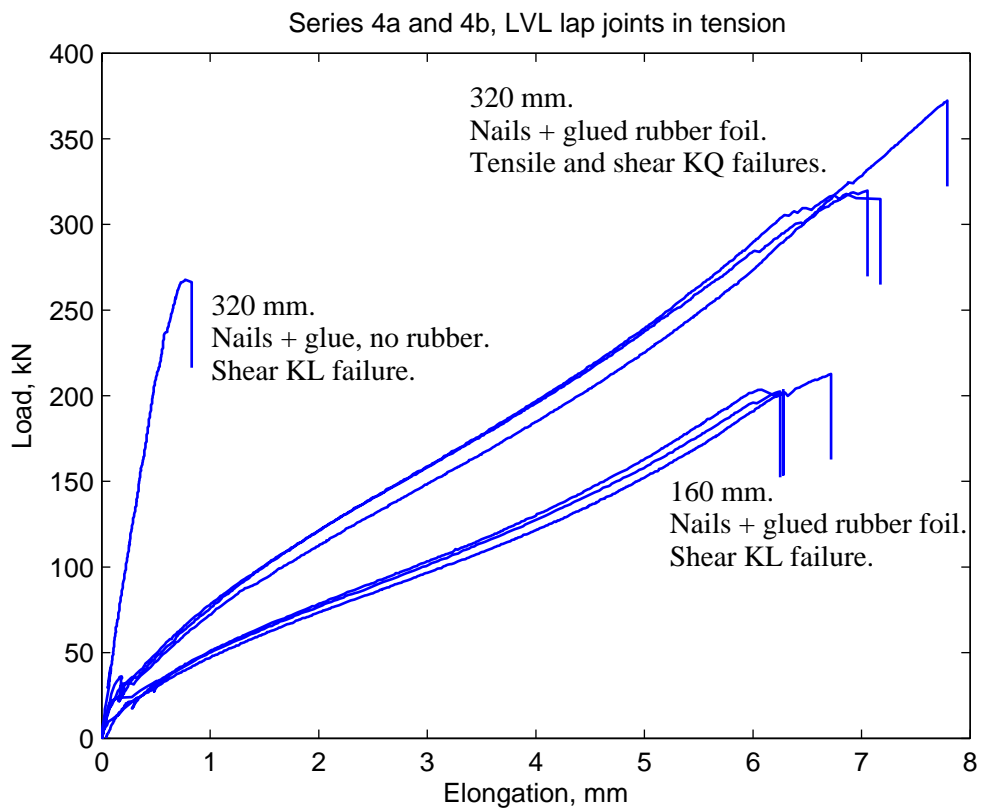
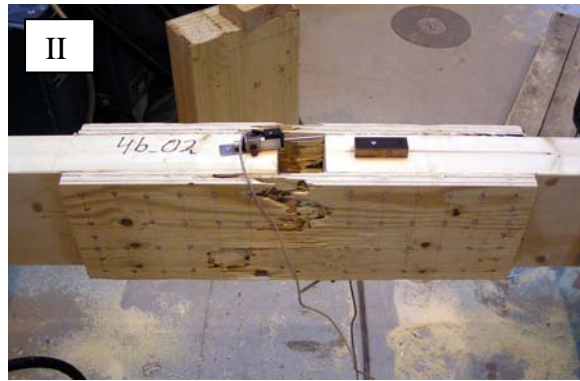
Test no.	P_f kN	δ_f mm	τ_f MPa	σ_f MPa	Failure, failure area 1	Failure, failure area 2
I	372	7.79	2.61	30.6	Tension-K	Shear-KQ
II	320	7.05	2.24	26.3	Tension-K	Tension-K
III	315	7.17	2.21	25.9	Shear-KQ	Shear-KQ
No foil	268	0.77	1.88	22.0	Shear-KL	Shear-KL

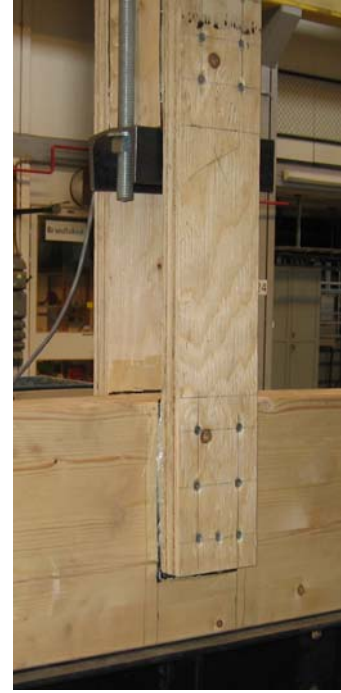
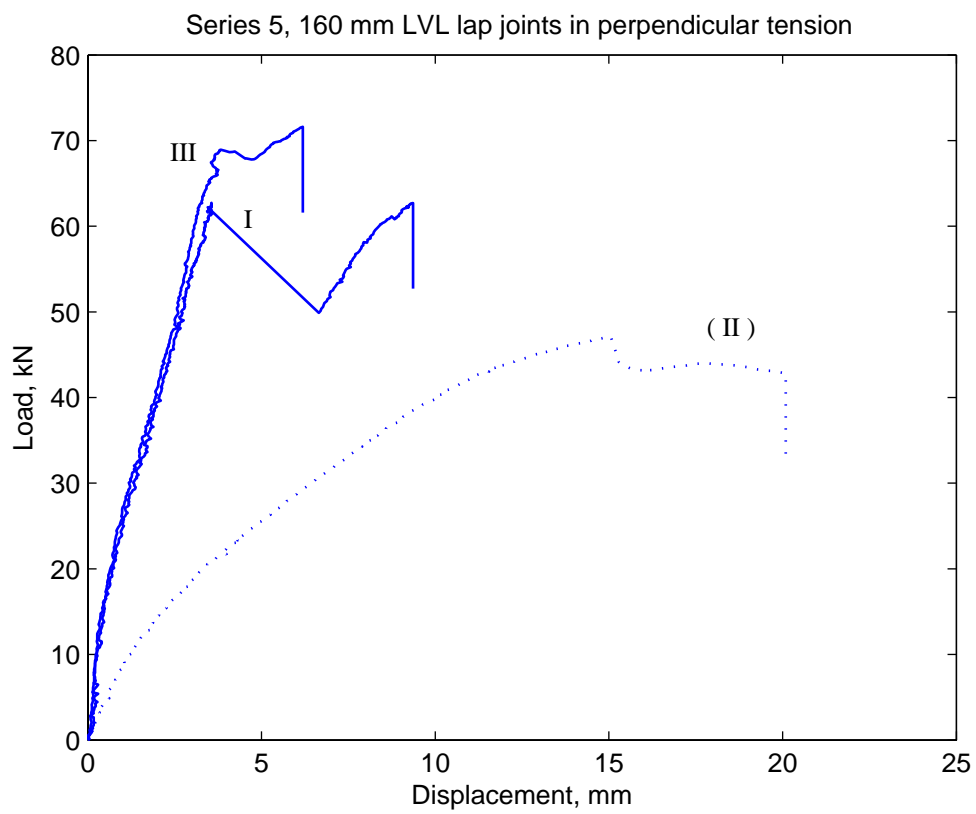
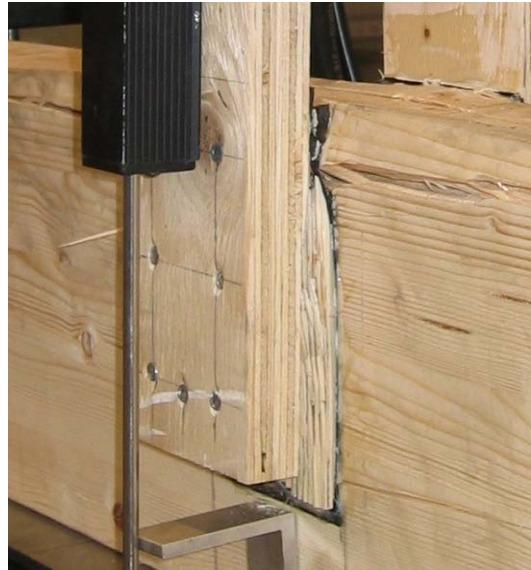
Test no.	P_f kN	δ_f mm	τ_f MPa	Failure, failure area 1	Failure, failure area 2
I	62.7	3.6	2.18	Longitudinal shear in LVL + rolling shear in glulam (+ Perp. to grain failure in beam.).	No failure. (Minor perp. to grain tensile failure at upper edge of beam.)
(II)	(47.2)	(15.1)	(1.64)	Glue missing.	Shear and tension-bending failure in LVL.
III	71.6	6.2	2.49	Longitudinal shear in LVL + perp. to grain failure in beam.	Longitudinal shear in LVL + perp. to grain failure in beam.

During test number II it was found that glue was missing in one of the rubber-LVL interfaces. The results obtained by specimen II are thus not valid for a symmetric specimen, having both LVL-parts glued to the rubber.

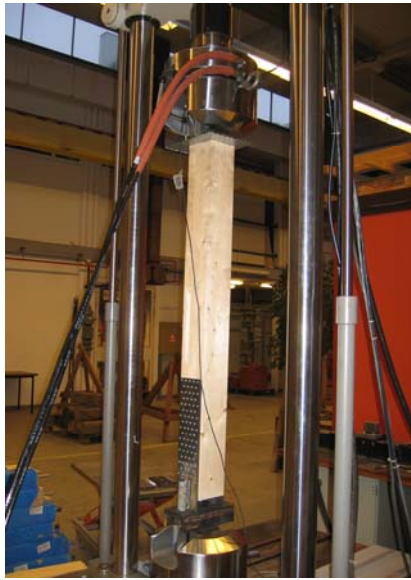
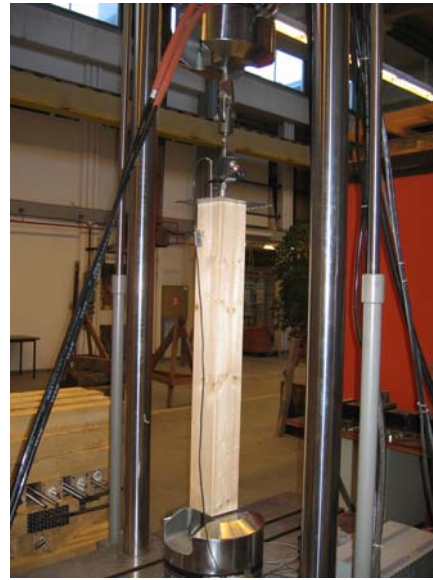
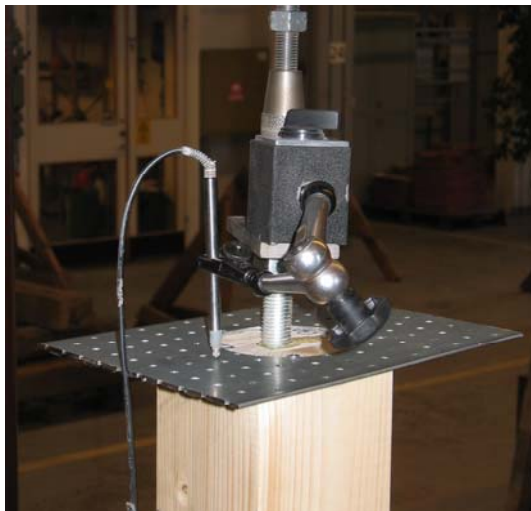
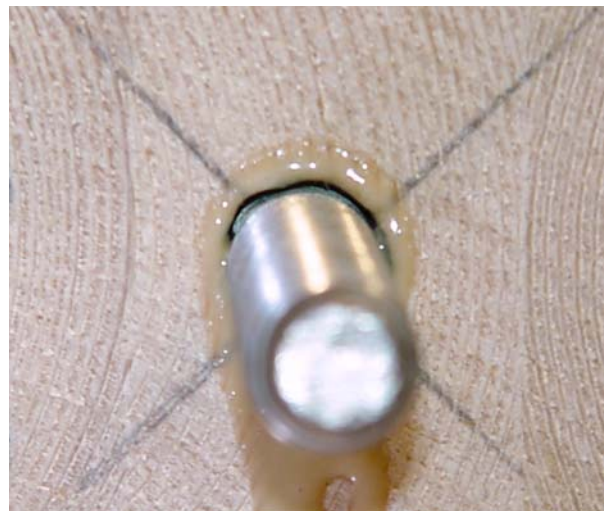
6.2 Test series 6a-9b, ramp loading of glued-in rods

The scatter in recorded displacement might partly be explained by the fact that the displacement was recorded only at one side of the rod, see above picture. For series 6c (glued threaded rod), it was apparent that many of the specimens were somewhat poorly glued. Glue had flown out from the hole when specimens were placed on the side before the glue was hard, leaving a non-glued area of a few cm^2 in size, see above picture. The ramp loading test results for series 10 are presented in section 6.3 together with the long duration of load test results. The rust seen on naked parts of the rods of the b I-IV specimens, i.e. parts not covered with rubber, may be related to the acid rinsing, see section 3.1.

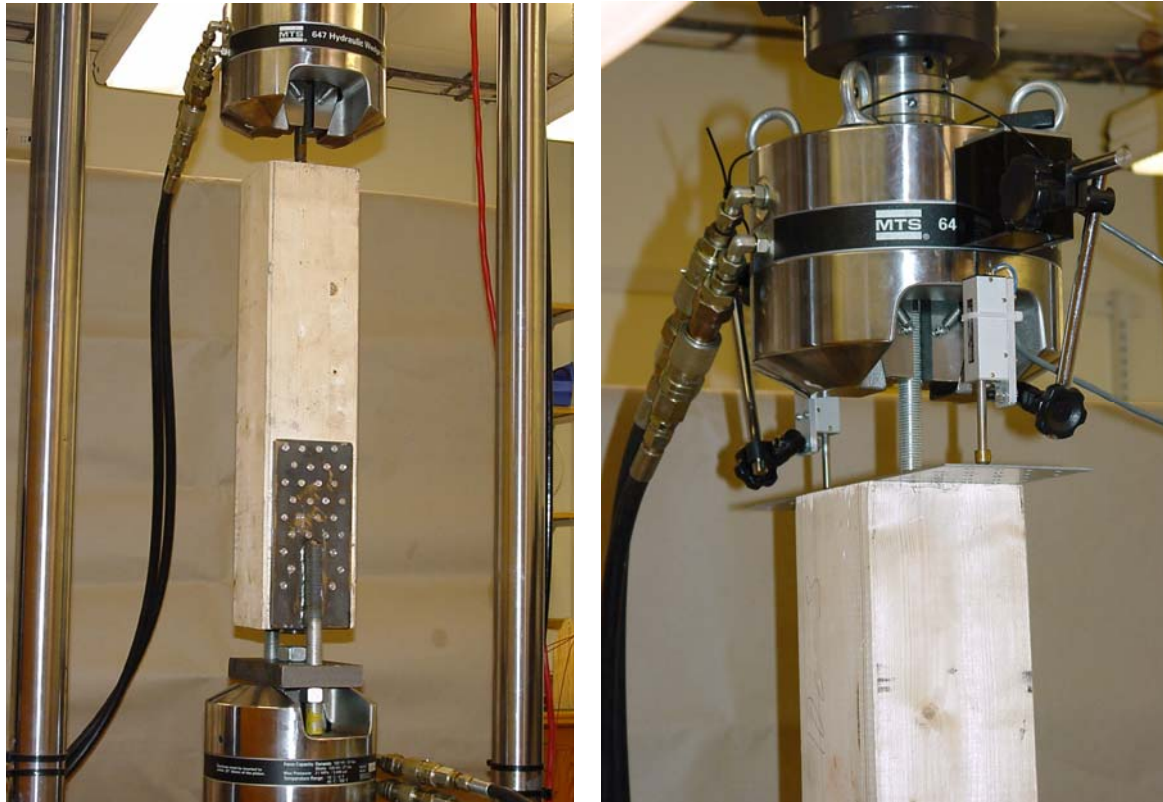
6.3 Test series 10aR-10cD3, DOL testing of glued-in rods

Above are photos showing the ramp load reference test before the constant load DOL tests. The actuator speed was constant during each ramp loading test, but different for the different tests, giving times to failure about in the order of 5-10 minutes. The following results were obtained:

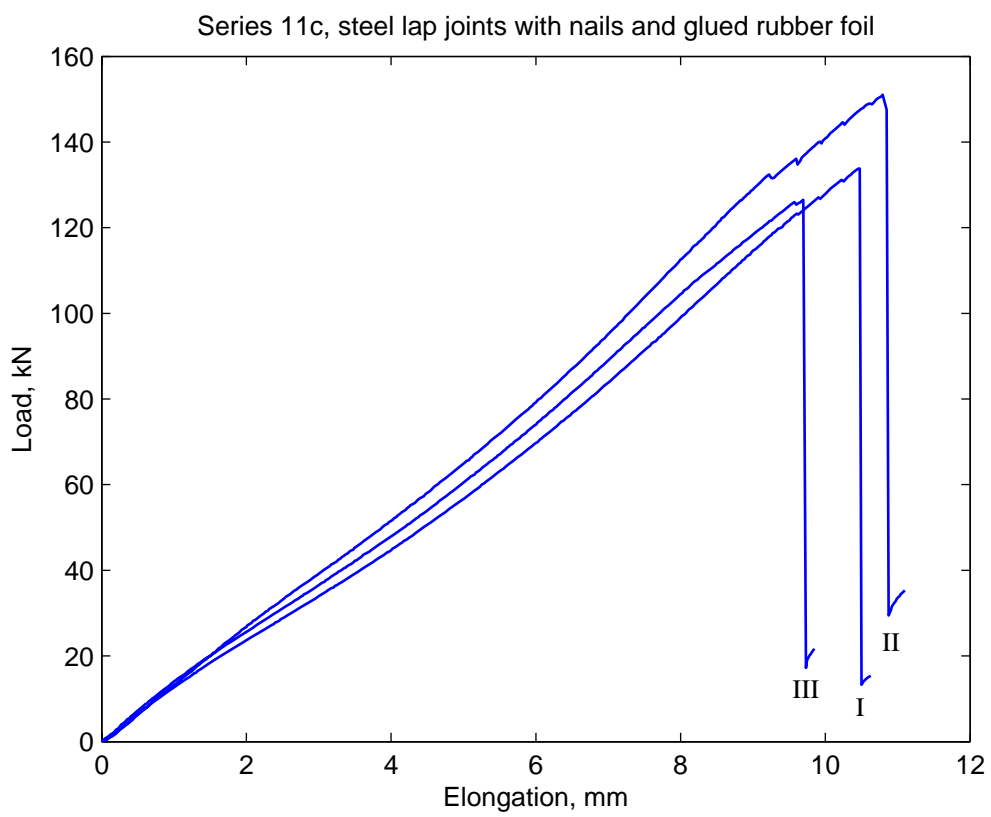
In the below are two diagrams shown, one giving a comparison between the results of series 11c with the results of 11a.

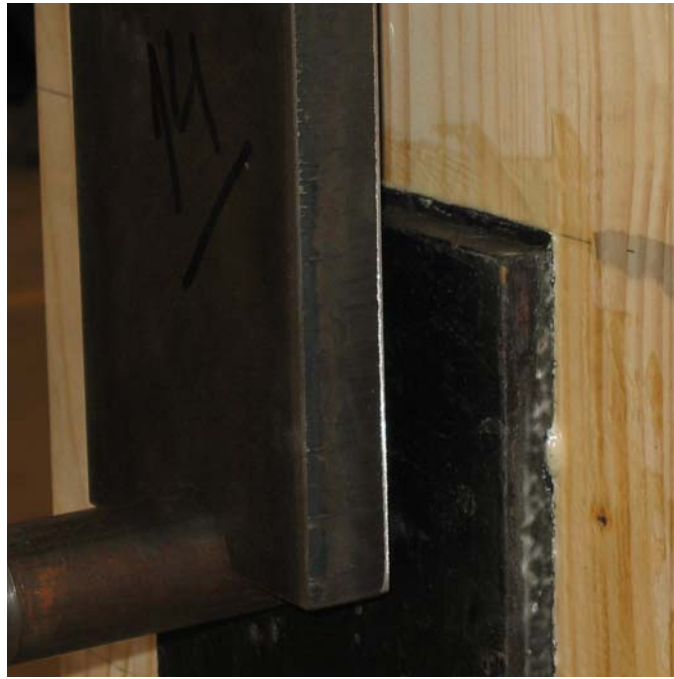
Test no.	P_f kN	δ_f mm	τ_f MPa	σ_f MPa	Cause of failure,
I	275.0	8.6	6.38	13.6	~100% shear fracture in wood
II	280.1	9.2	6.50	13.9	~ 70% shear fracture in wood ~ 20% fracture in rubber surface at wood side ~ 10% fracture in rubber layer
III	277.7	8.7	6.45	13.8	~ 70% shear fracture in wood ~ 30% fracture in rubber surface at wood side

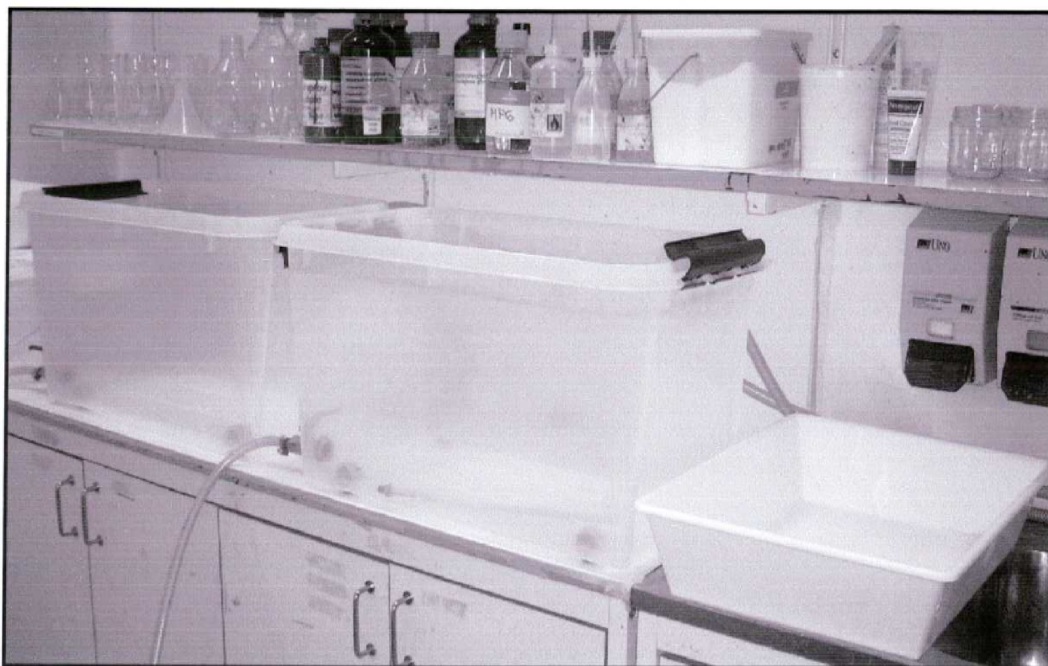
Figur 3. Vattenbad (till vänster och i mitten) och syrabad (till höger).

För att möjliggöra syrabehandling av gummi krävdes att en sköljningsanordning av tillräckligt stora dimensioner kunde användas. Två stora syrabeständiga plastbehållare, tillverkade av polypropen, införskaffades på Clas Ohlsson och förseddes med krananordning och slanganslutningar, se *figur 3*. Till dessa anslöts kommunalt vatten via en vanlig vattenkran som möjliggjorde fortgående utbyte av vatten i behållarna.

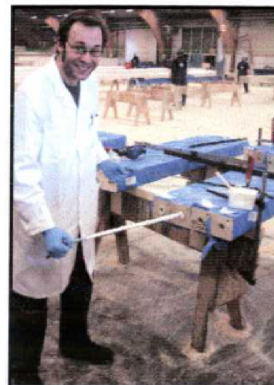
Figur 7. Applicering av lim, inlimmade stänger.

- Nedre hål: För att få in limmet i borrhålen användes en ca 1m lång järnstång som doppats i lim, se *figur 7*. Lim applicerades även direkt på stängerna för bättre spridning. De gängade stängerna applicerades med en maskin som skruvar in stängerna i provkroppen, se *figur 8*.

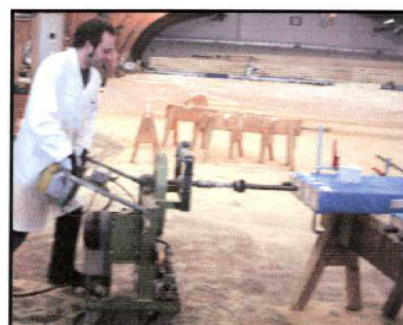
Figur 8. Applicering av gängade stänger.

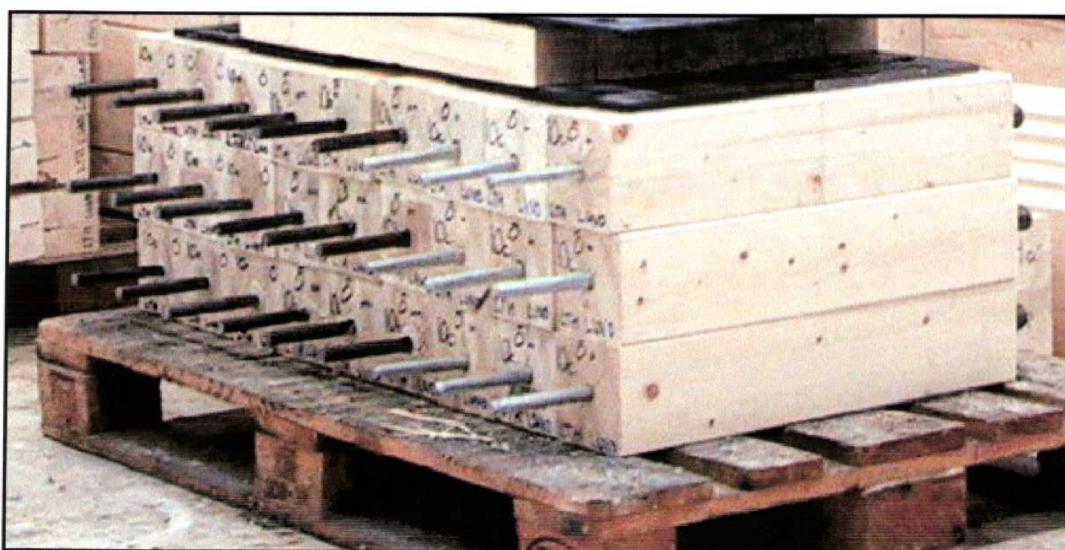
Figur 9. Förvaring av inlimmade stänger.

- Limmet fick härda över natt, sedan lades de vågrätt för förvaring, se *figur 9*.

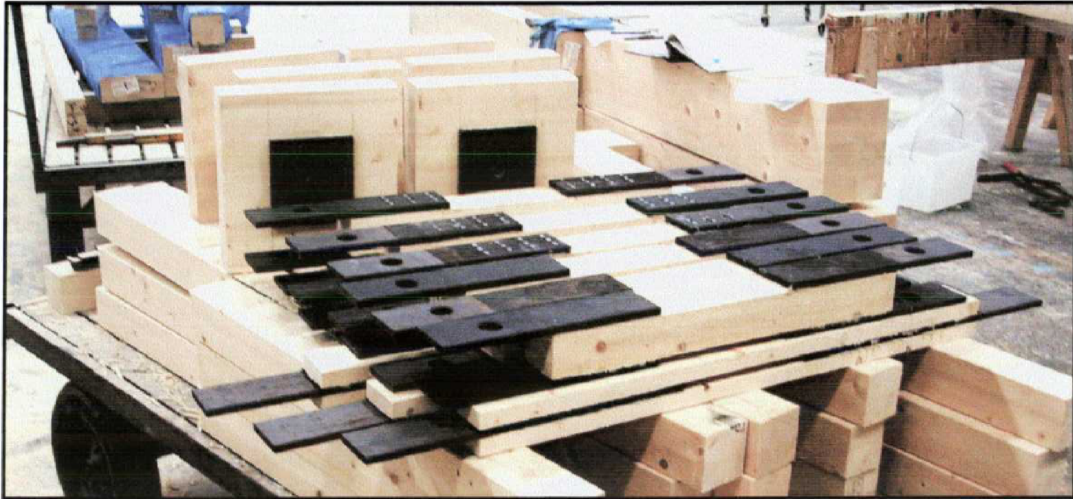
Figur 10. Förvaring av provkroppar från serie 11-14.
